Pond Dams Built Right

There is a desire to have a pond dam built. Or you come across one with problems. An actual design specific for the site is best. But many times, that is not possible. This presentation outlines components key to having a "Pond Dam Built Right."

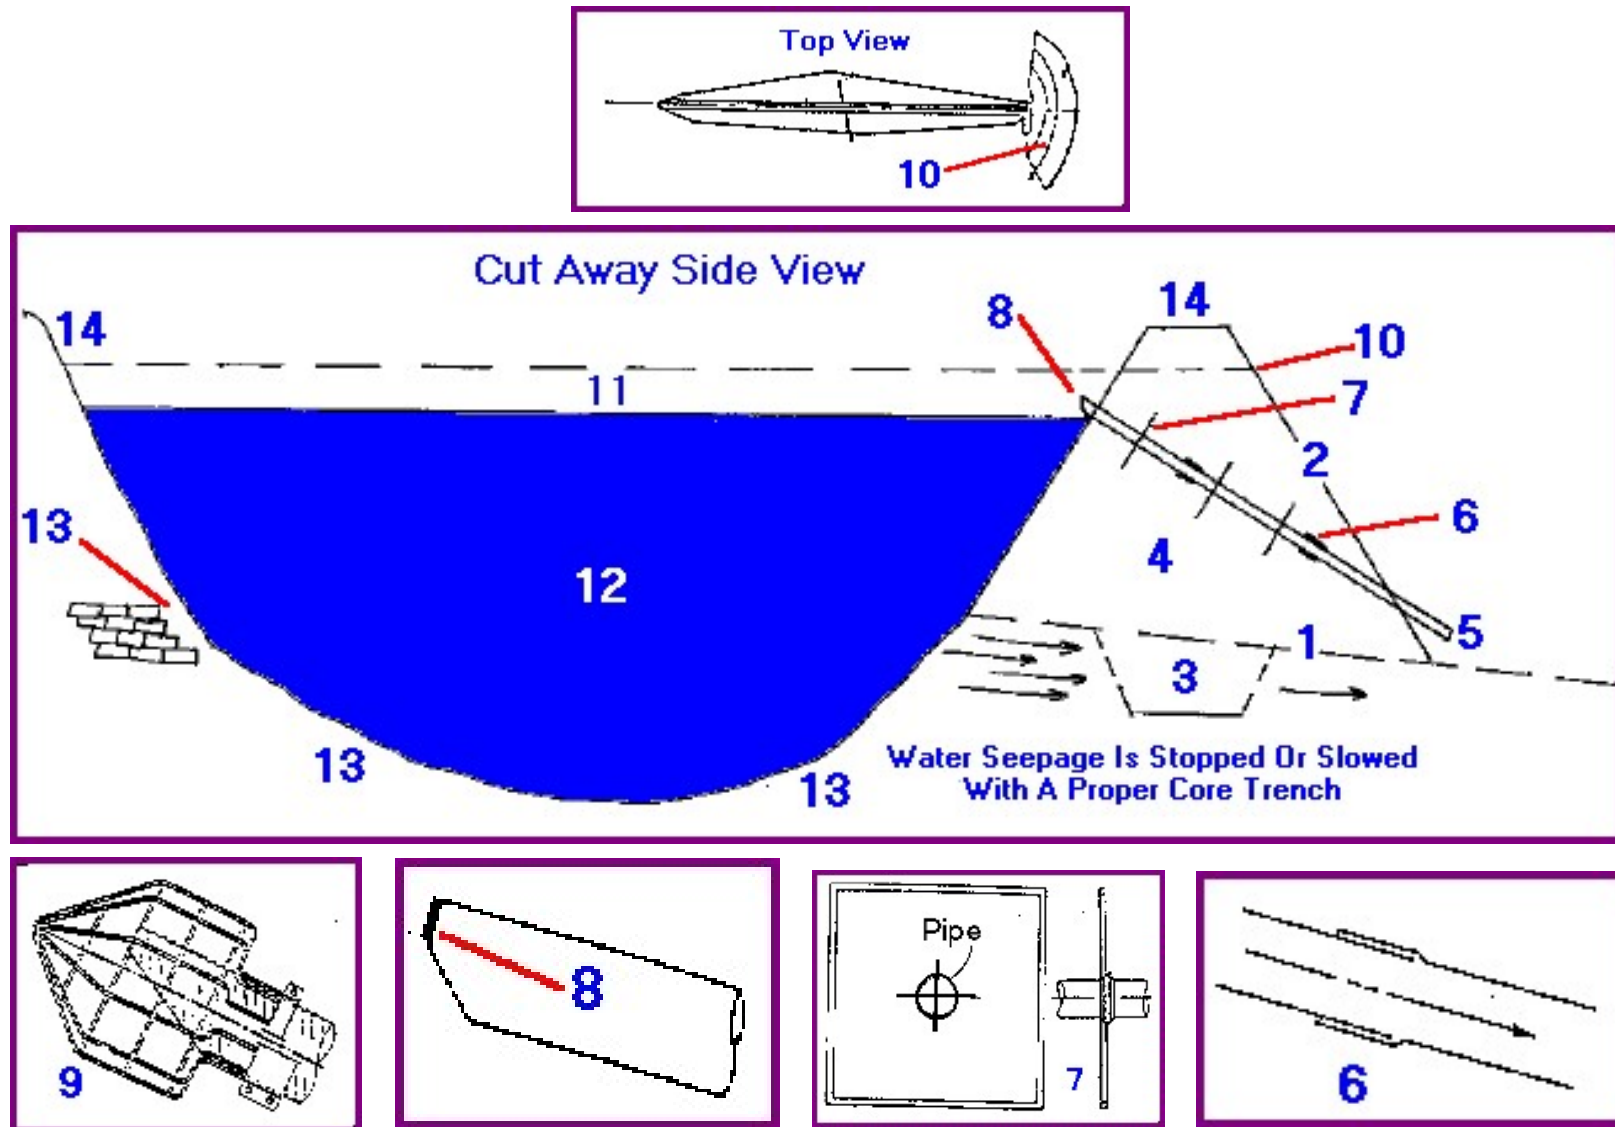
BASIC ELEMENTS OF A POND DAM

Basic elements

A referenced number guide to this image is available on this website under "Pond Dams Built Right – Drawings and Text"

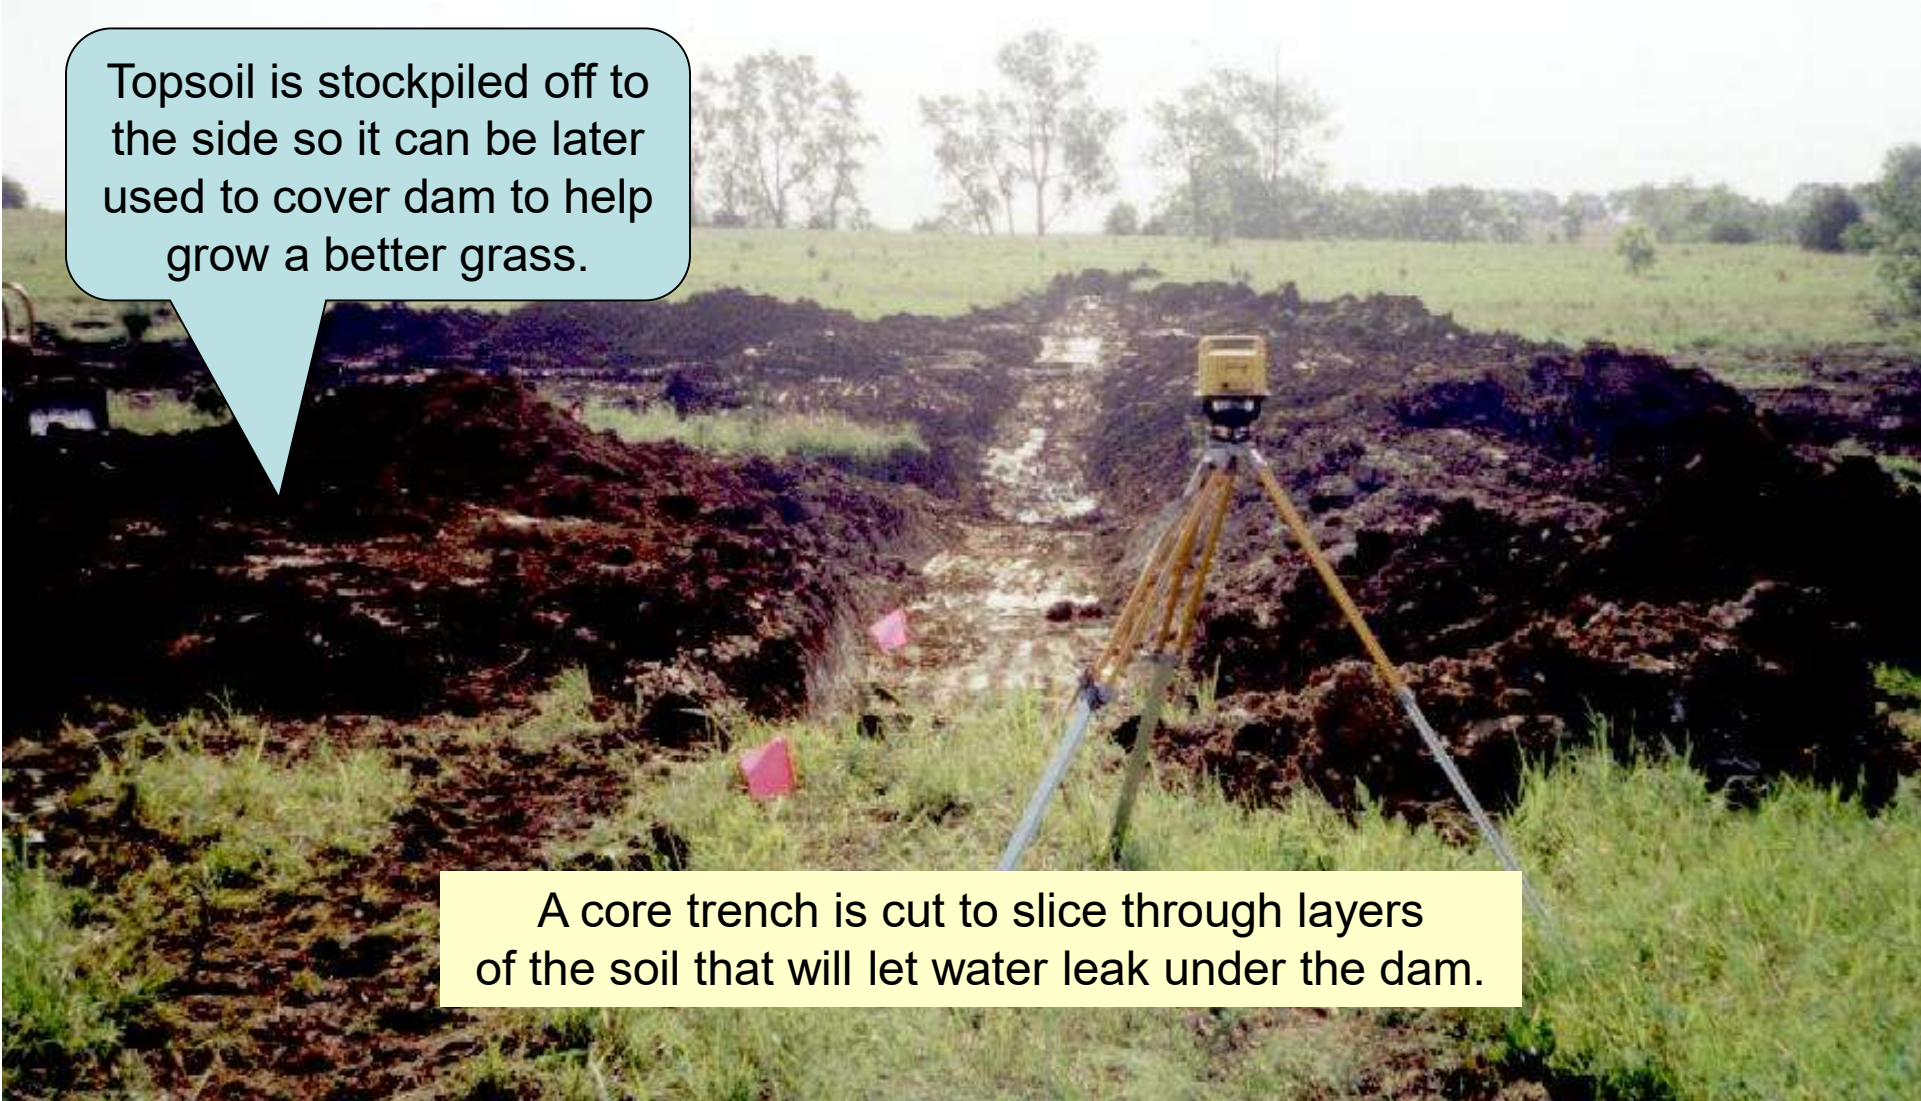
Topsoil is stockpiled off to the side so it can be later used to cover dam to help grow a better grass.

A core trench is cut to slice through layers of the soil that will let water leak under the dam.

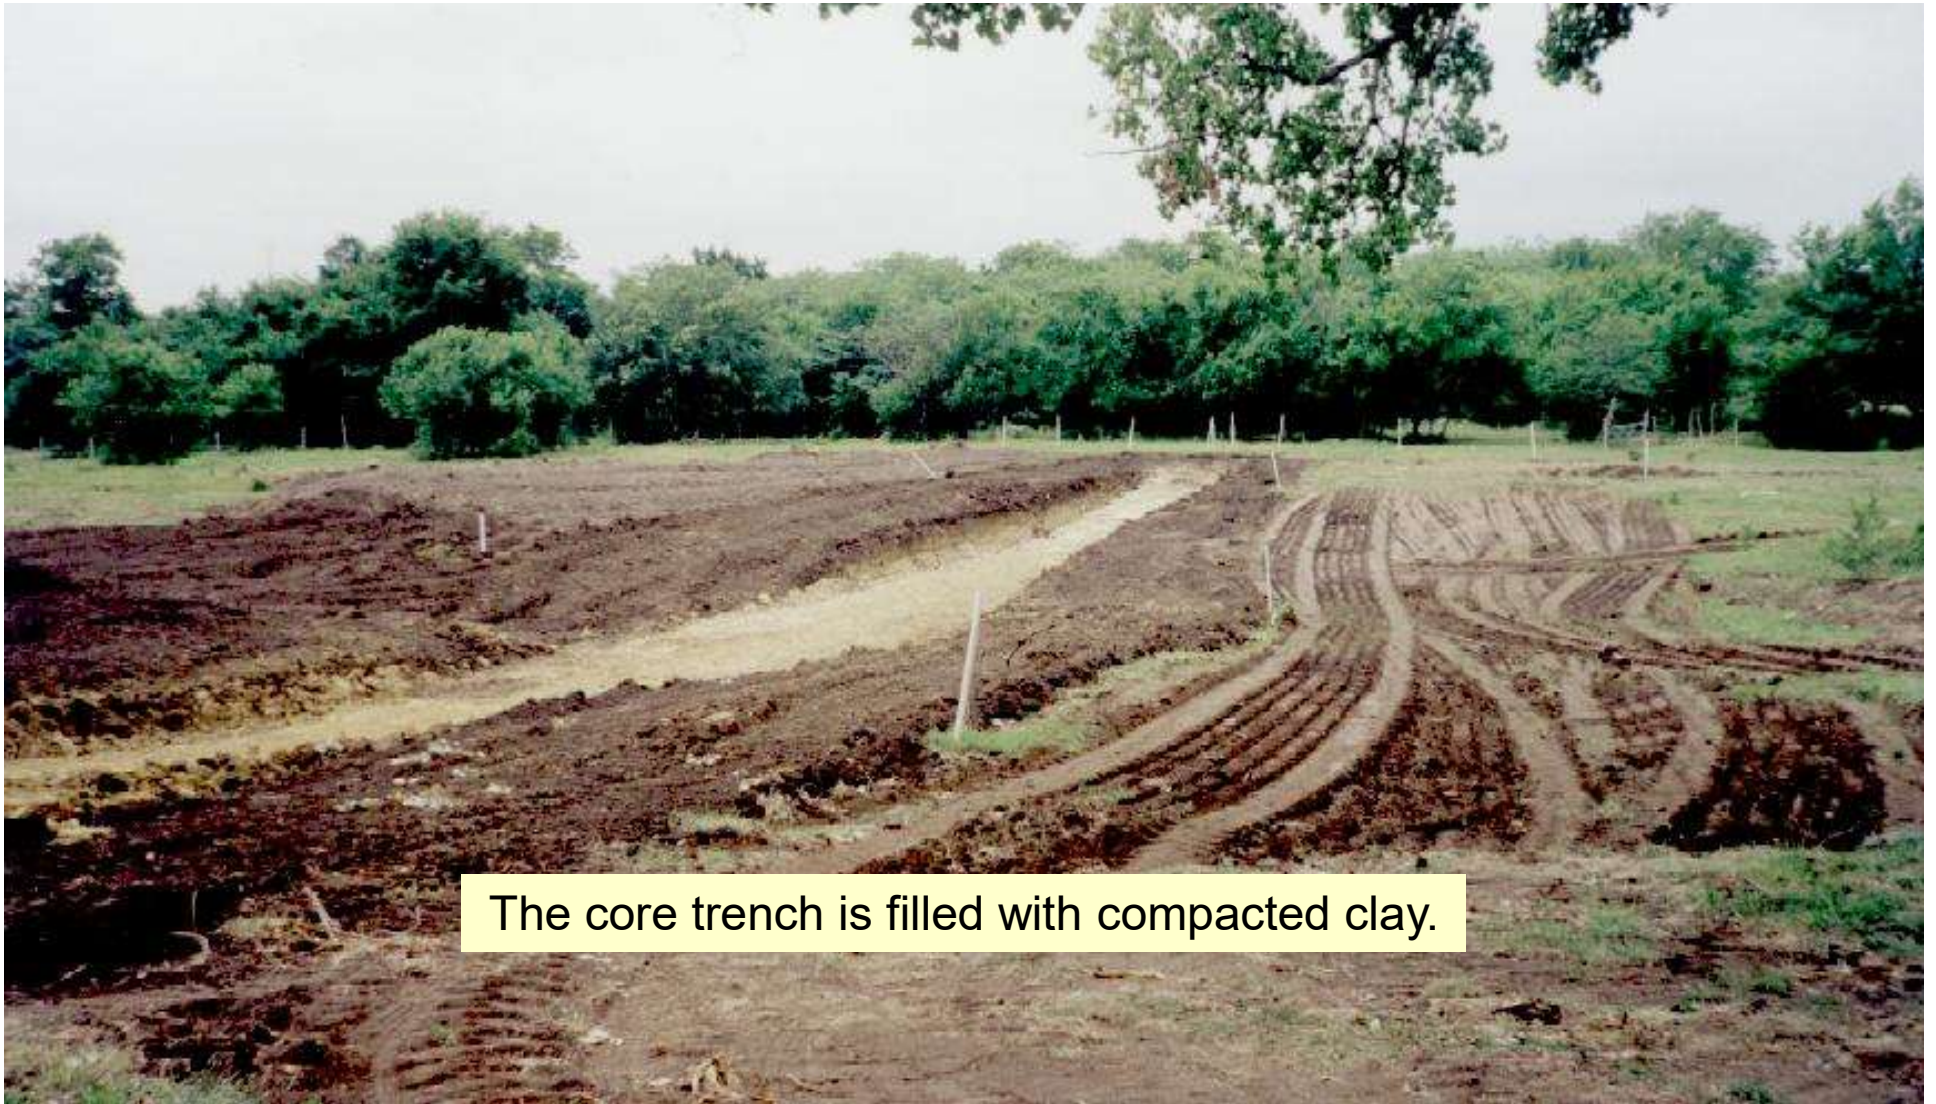
The core trench is filled with compacted clay.

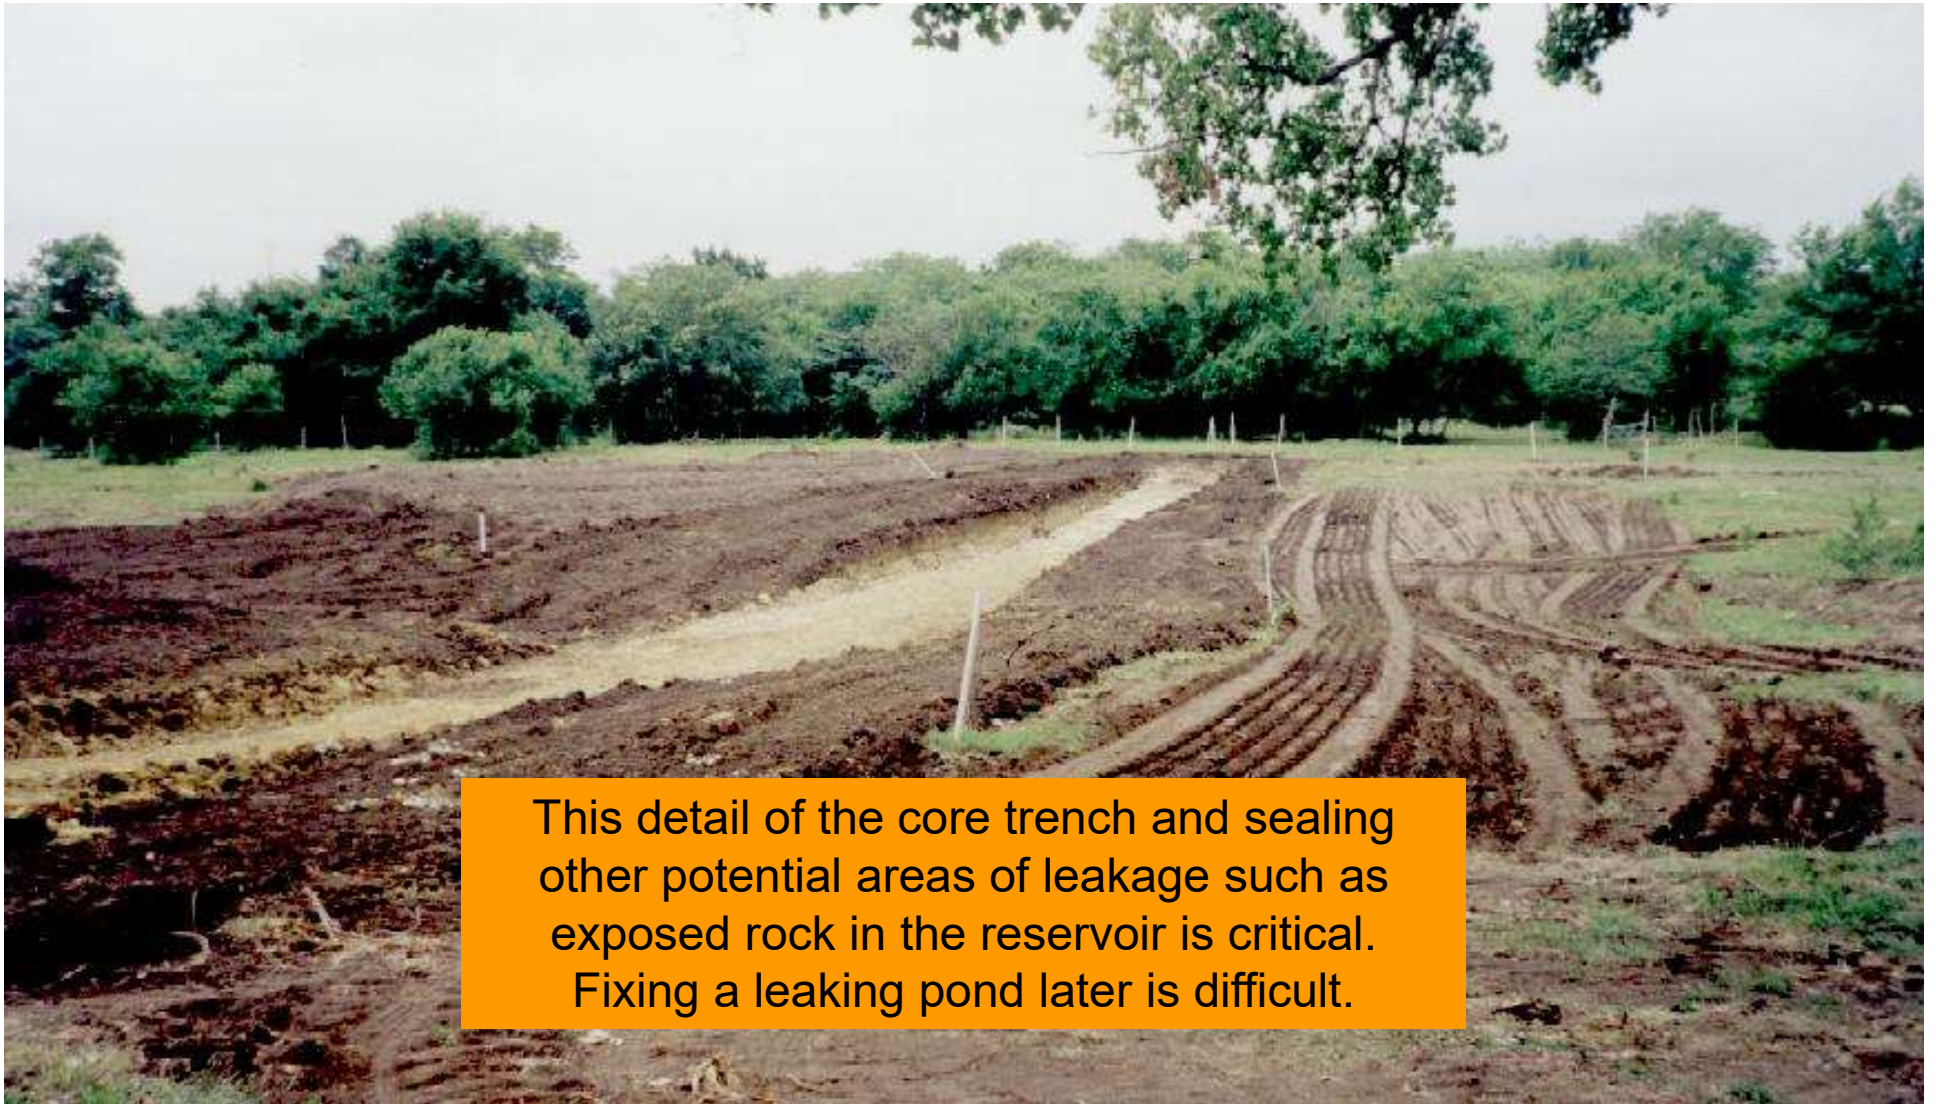
This detail of the core trench and sealing other potential areas of leakage such as exposed rock in the reservoir is critical. Fixing a leaking pond later is difficult.

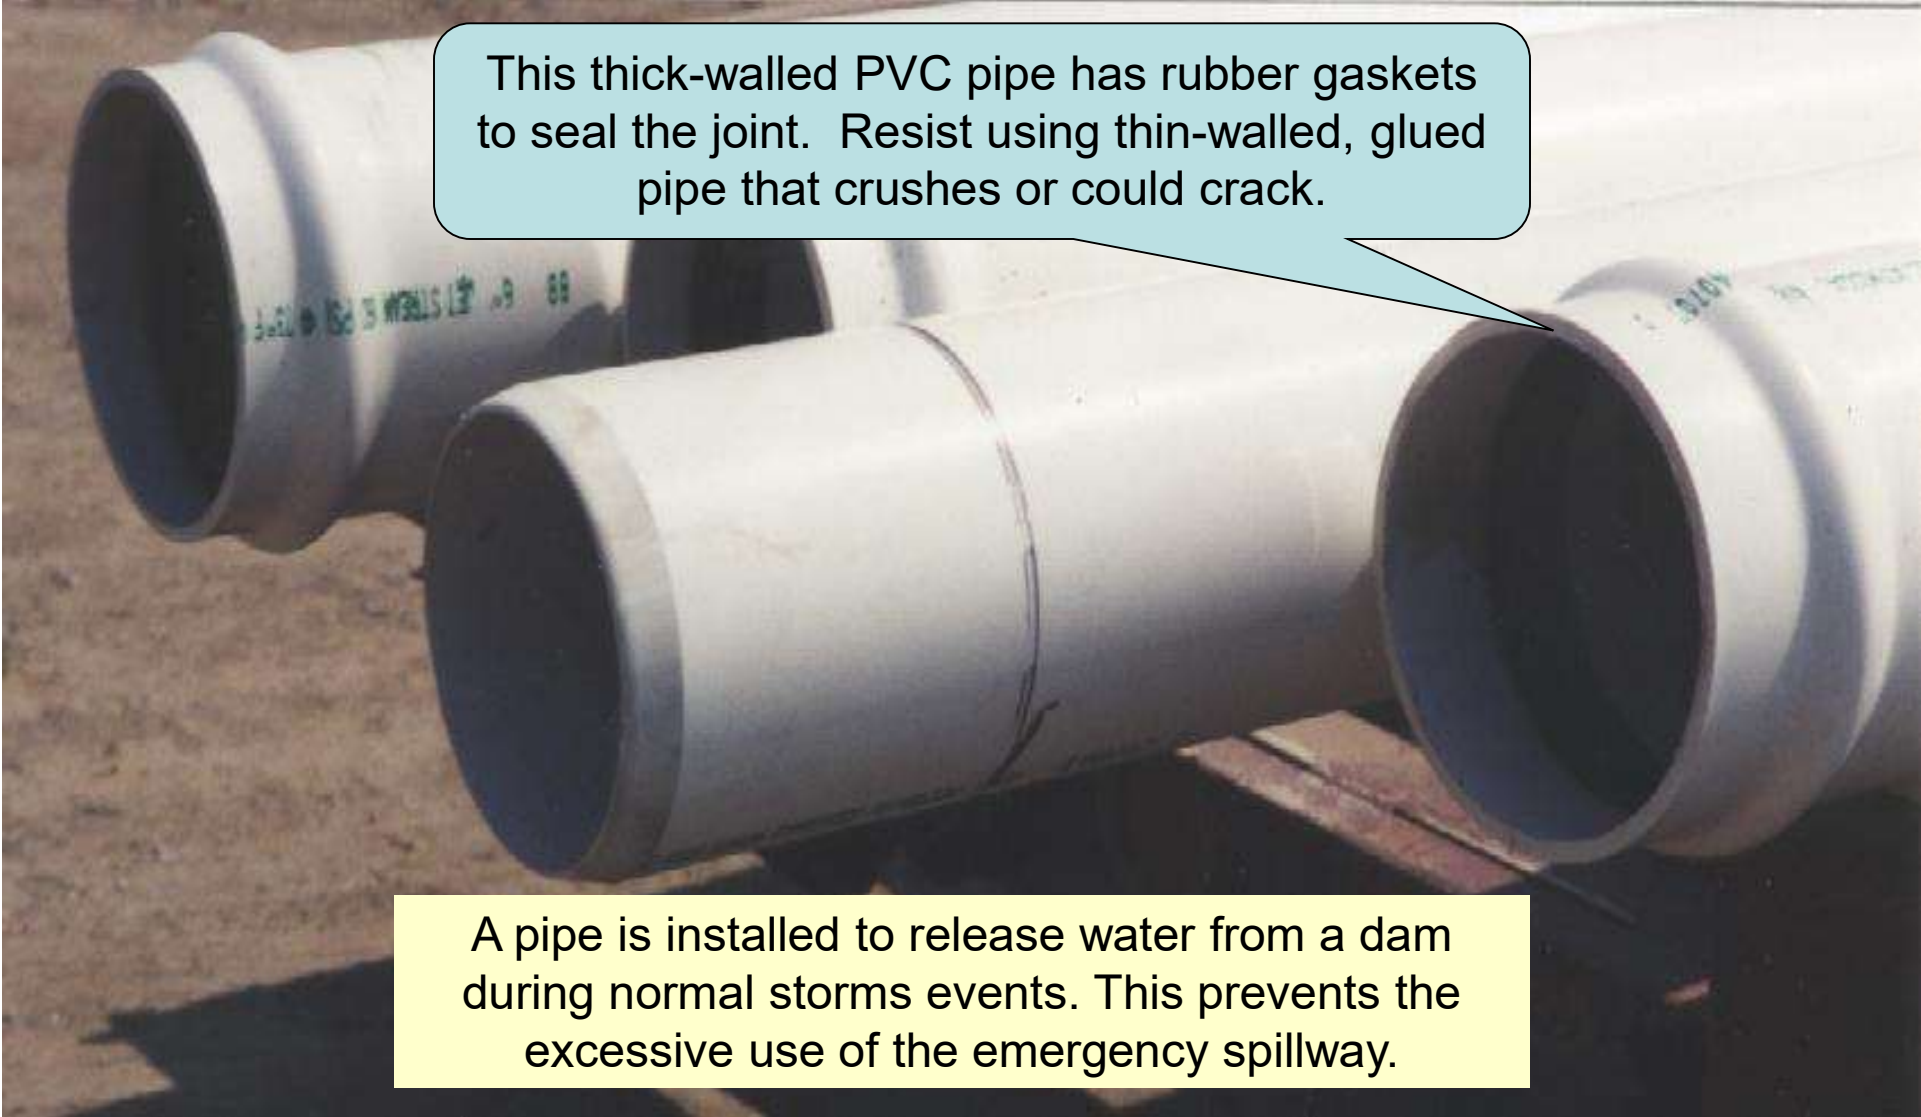
This thick-walled PVC pipe has rubber gaskets to seal the joint. Resist using thin-walled, glued pipe that crushes or could crack.

A pipe is installed to release water from a dam during normal storms events. This prevents the excessive use of the emergency spillway.

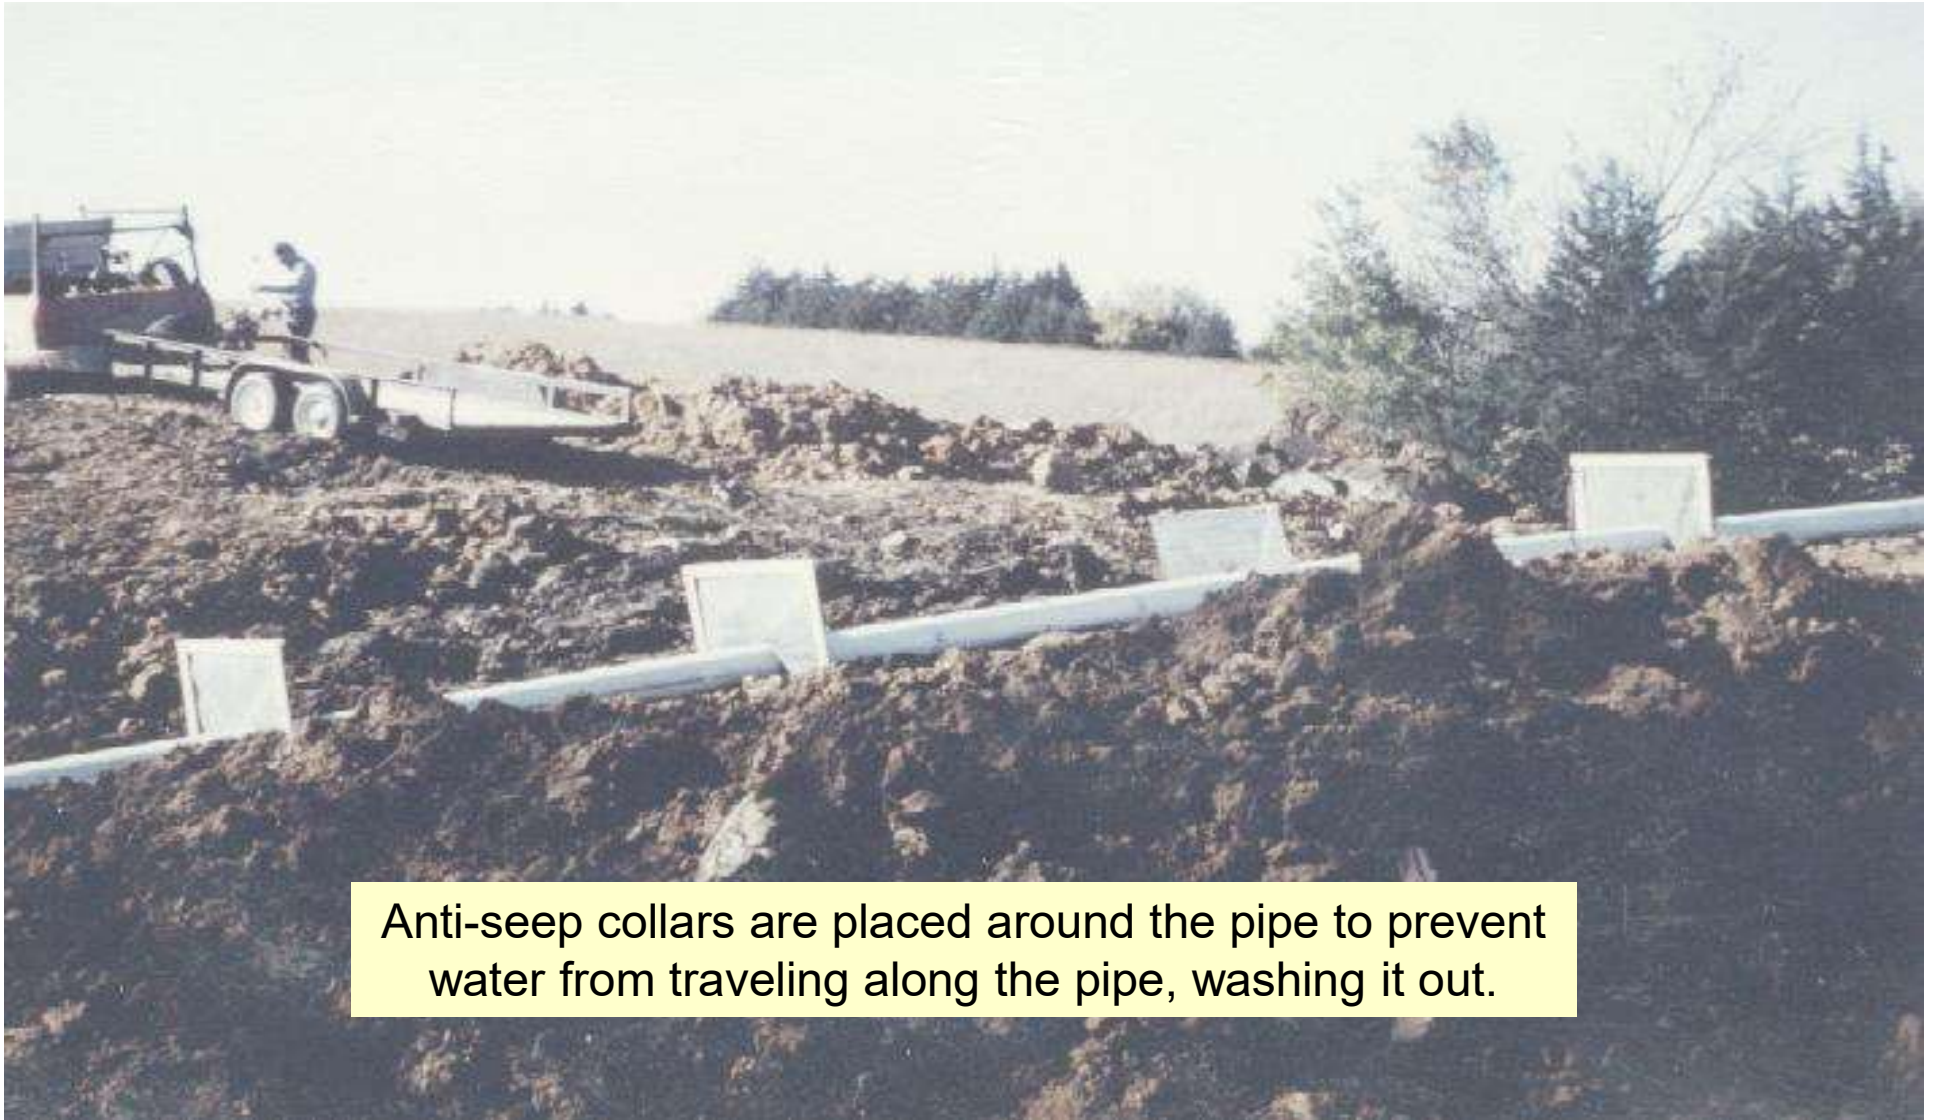
Anti-seep collars are placed around the pipe to prevent water from traveling along the pipe, washing it out.

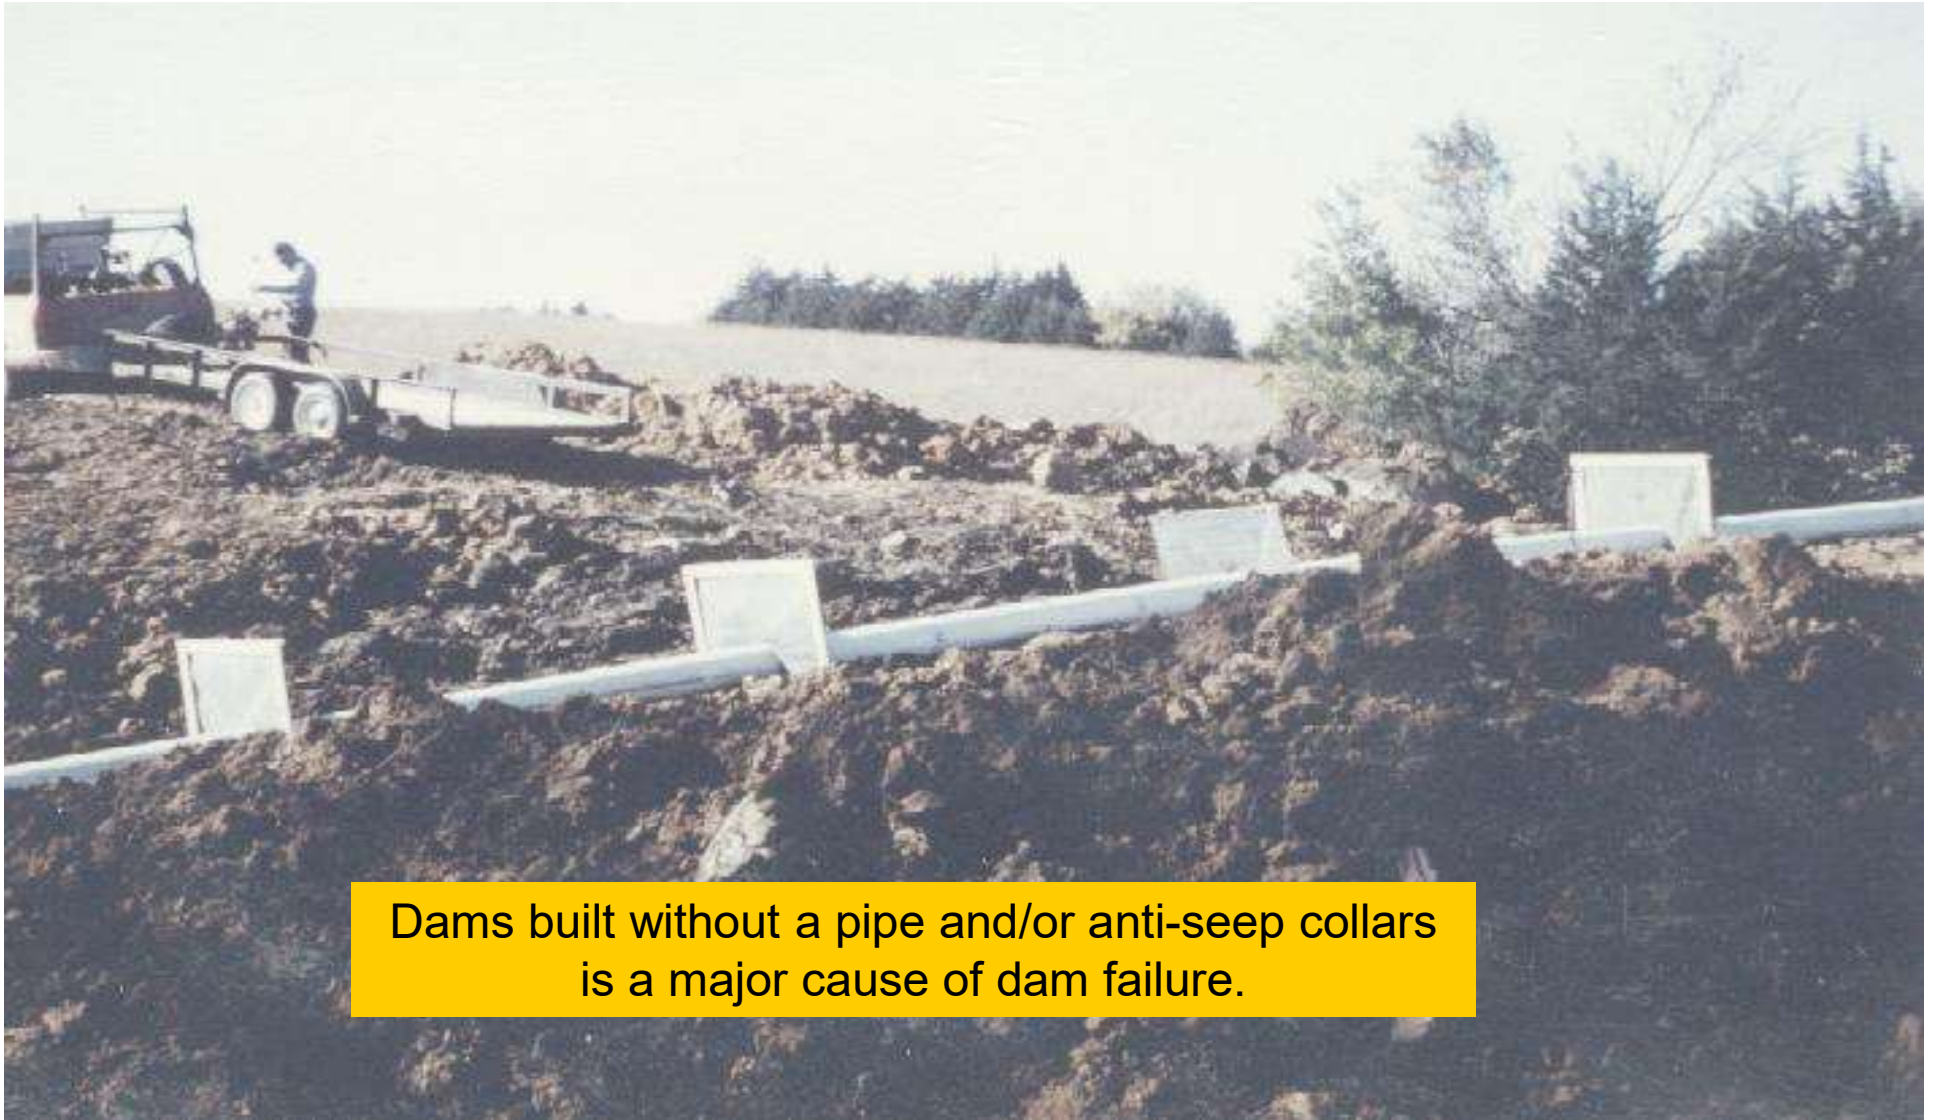
Dams built without a pipe and/or anti-seep collars is a major cause of dam failure.

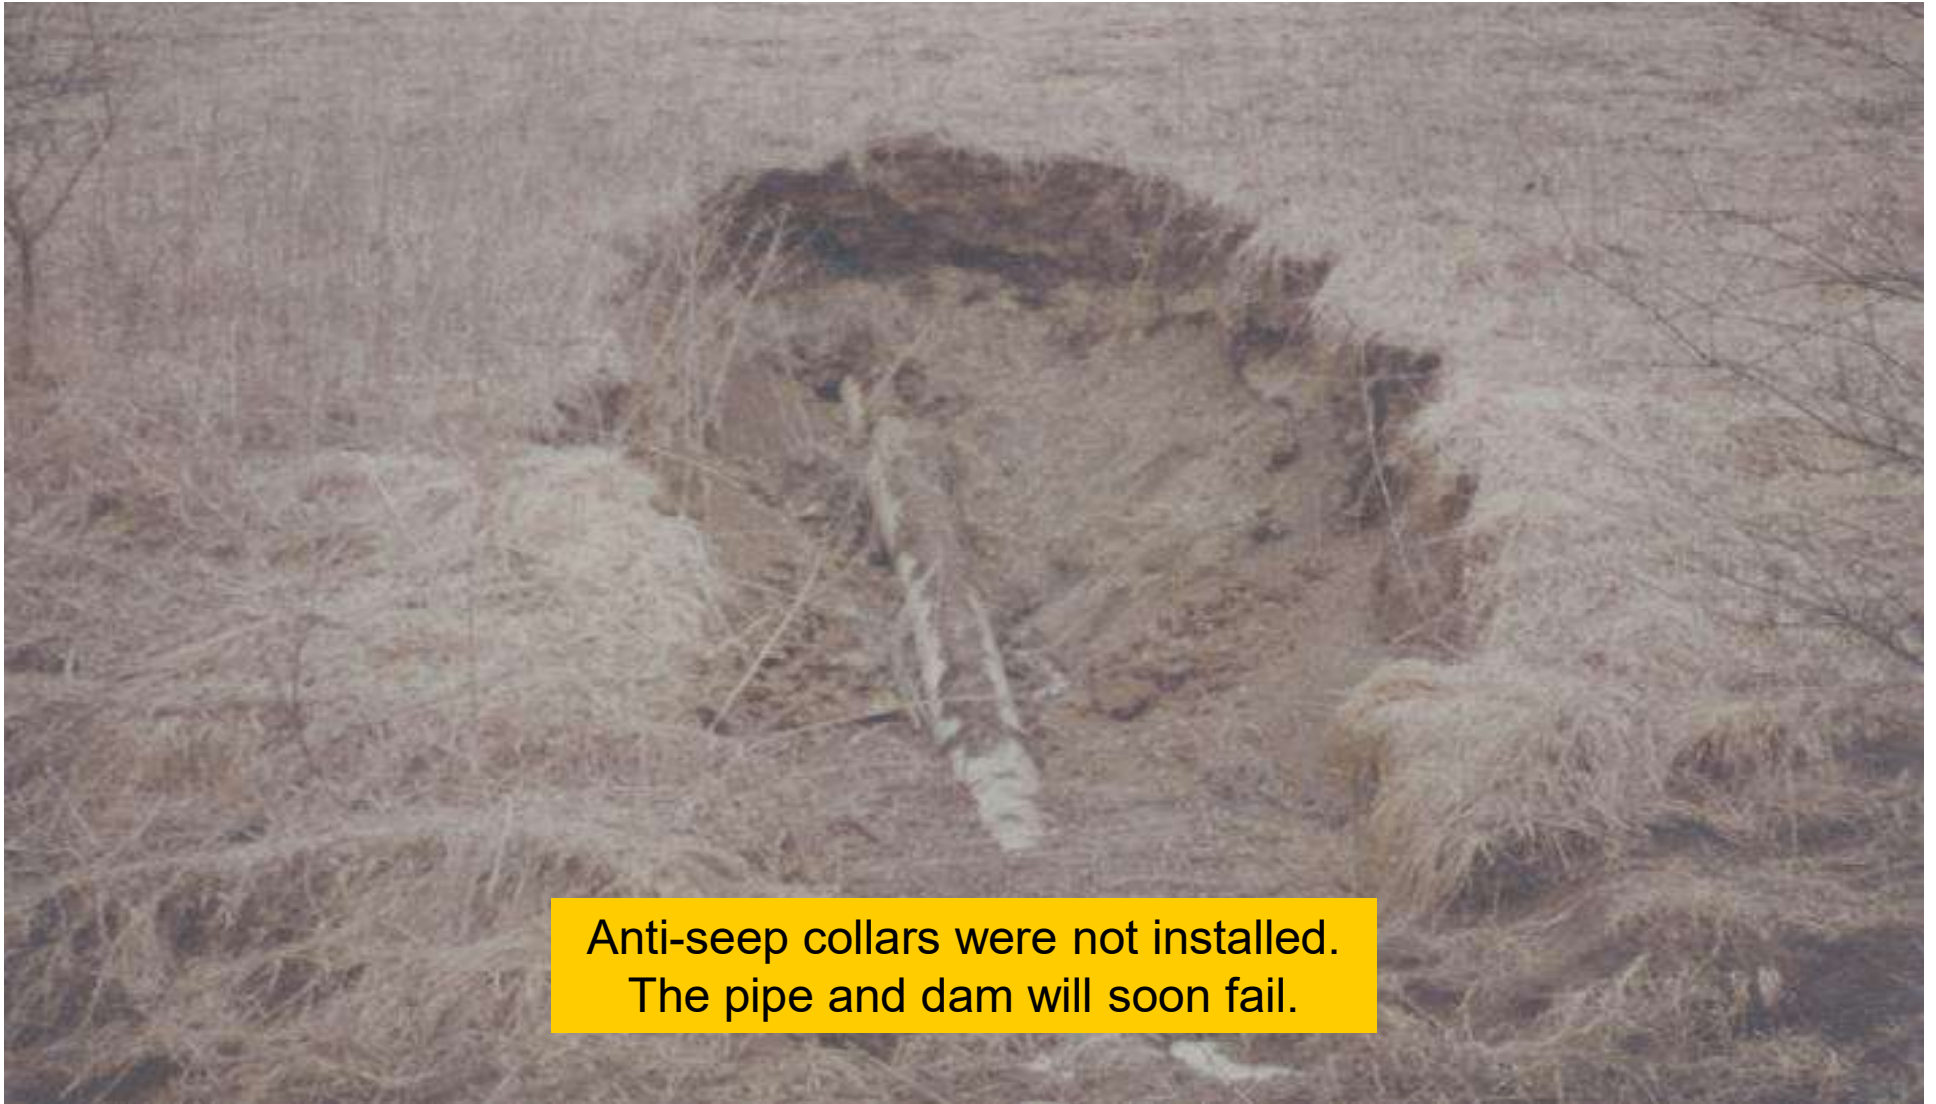
Anti-seep collars were not installed.
The pipe and dam will soon fail.

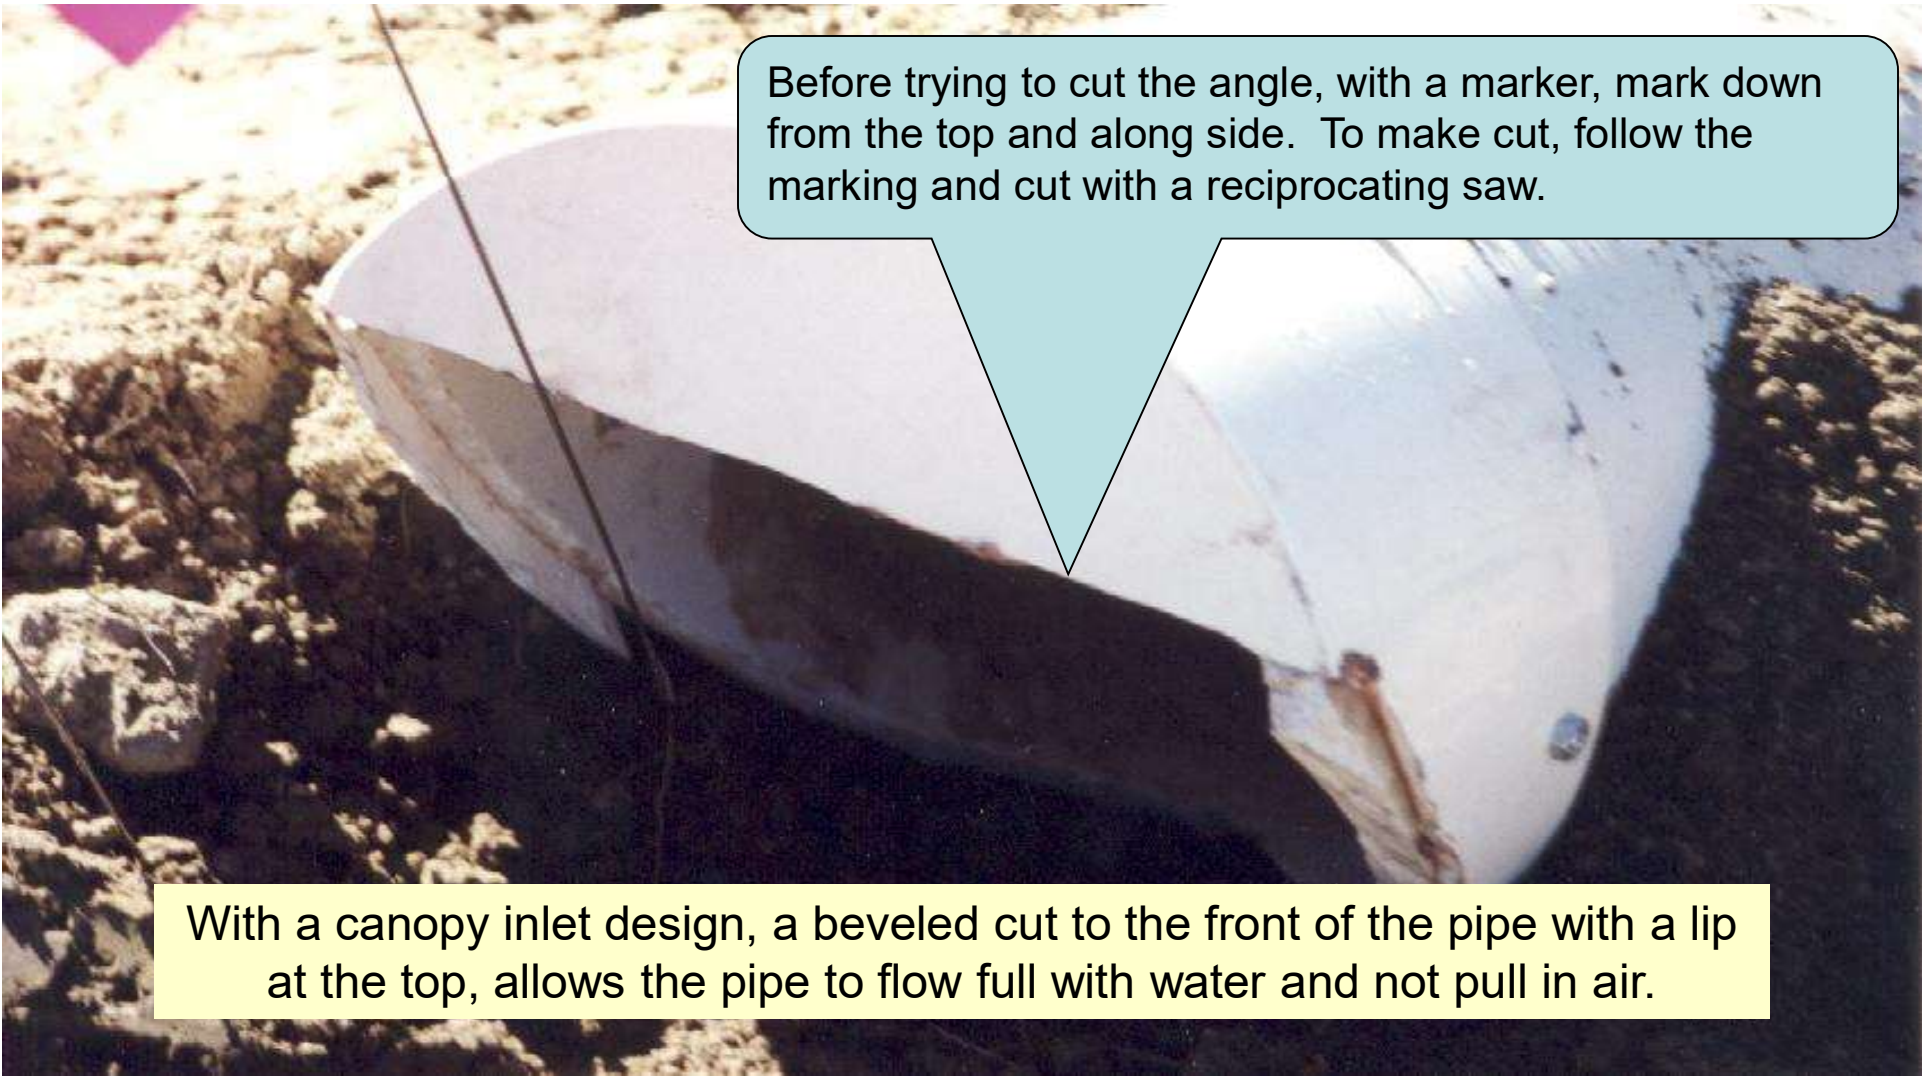
Before trying to cut the angle, with a marker, mark down from the top and along side. To make cut, follow the marking and cut with a reciprocating saw.

With a canopy inlet design, a beveled cut to the front of the pipe with a lip at the top, allows the pipe to flow full with water and not pull in air.

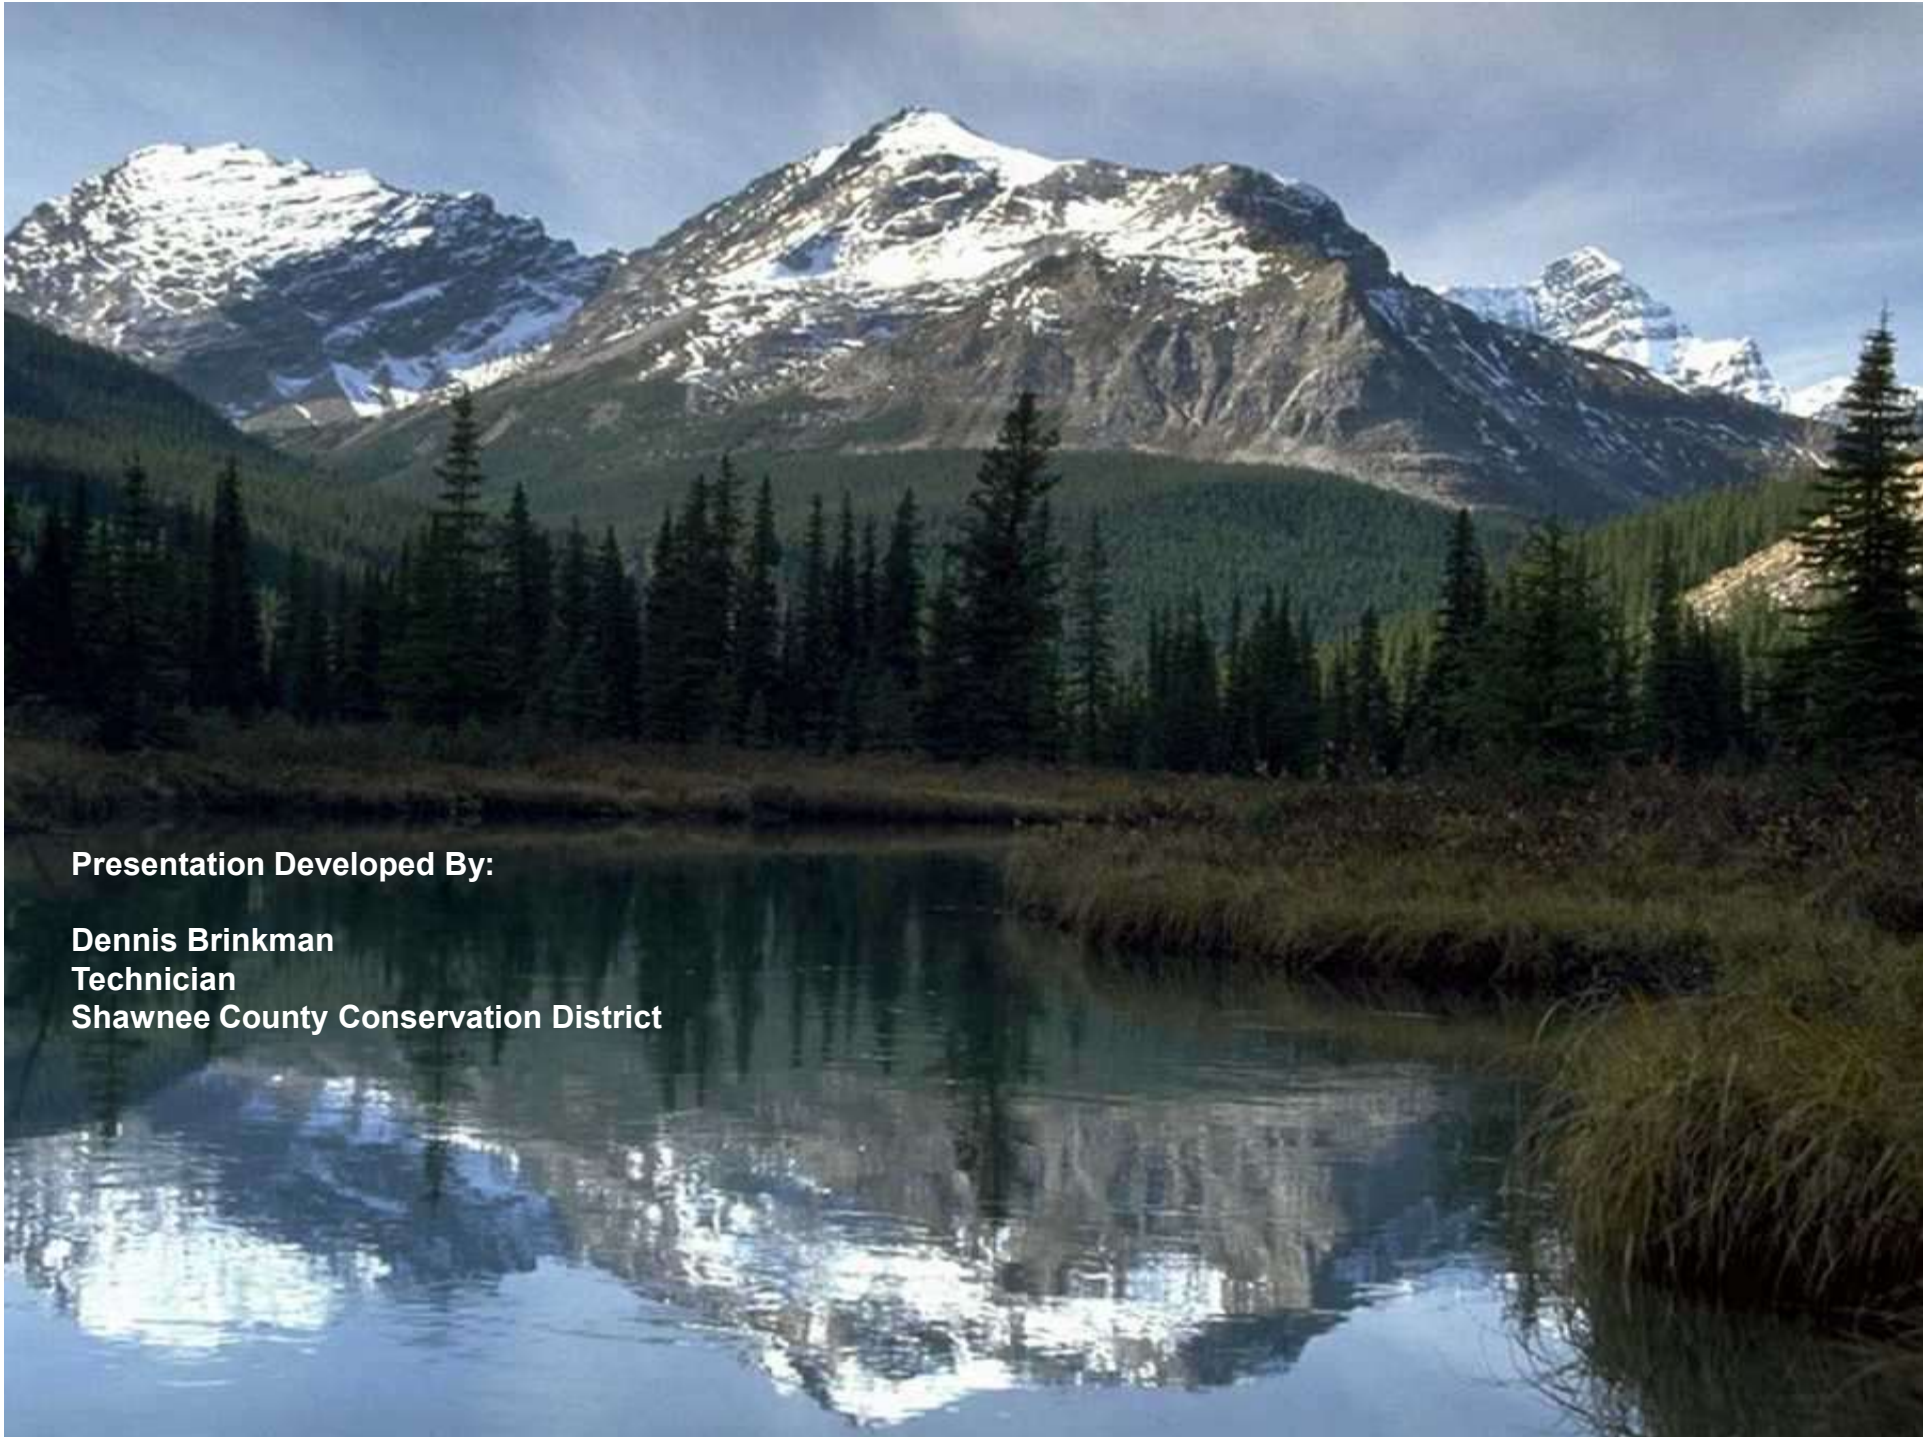
Properly constructed and maintained dam.
